**Re: Range Resources Appalachia, LLC's Response to June 11, 2010
 Request for Information**

Subject: Incident Report
Range Resources – Appalachia LLC
Cross Creek County Park Well Nos. 14H, 15H, and 16H
Well Permit Nos. 37-125-23165-00, 37-125-23182-00, and 37-125-23300-00
Hopewell Township, Washington County, Pennsylvania

Description of Incident

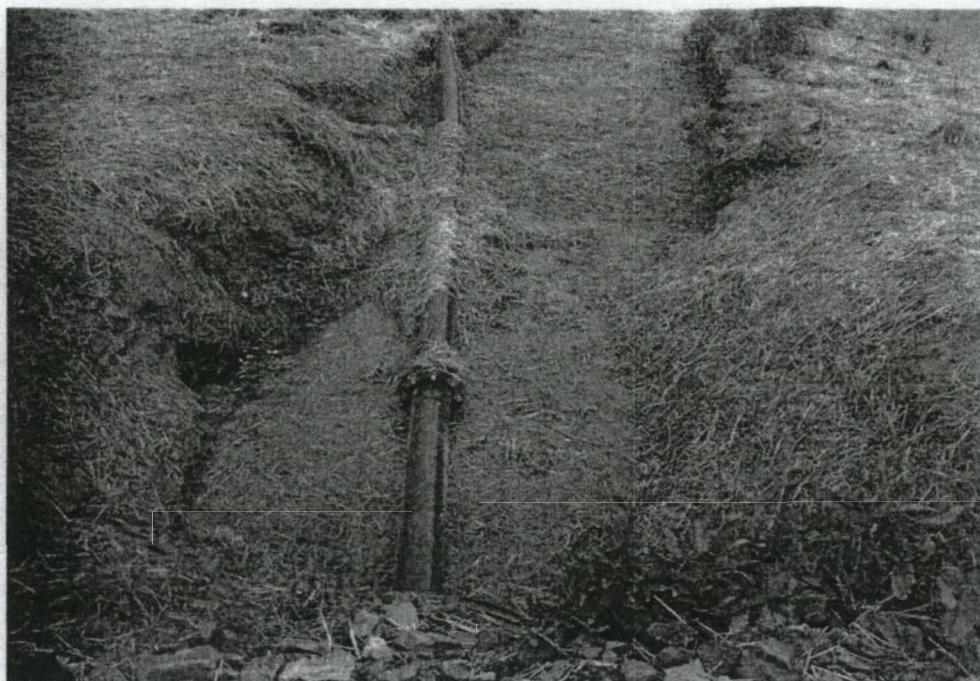
PHOTO #1

Range Resources personnel immediately shut down the flowback operation when the leak of flowback water was discovered. Upon further investigation, Range Resources personnel determined that the water had leaked from the pipe at the location of 2 of the couplings due to the fact that 3 of the bolts for each of the couplings were loosened. Range Resources was unable to determine how the bolts, all on the underside of the couplings, were loosened. Due to the loose bolts, the water leaked, pooled in a low spot of the existing ground surface at the location of the leak, and then flowed via overland flow into an unnamed tributary to Cross Creek. When Range Resources personnel had assessed the situation, DEP personnel were then notified via telephone at approximately 5:15 pm. The attached photographs show the location of the leak.

Coupling where loose bolts were found and leak occurred. Picture was taken after clean-up and water in low spot at pipe is fresh water.

In the future, the use of bolted flanged couplings will be minimized or eliminated on piping being used to convey flowback water. Additionally, line inspections will be performed more frequently, especially at bolted flanged connections. When pumping is ceased between stages of water conveyance, all flanged connection integrity will be verified. If required, the connections will be tightened prior to commencement of pumping water through the piping for the next stage. Finally, if possible, spill containment kits will be located along the line where there are bolted connections.

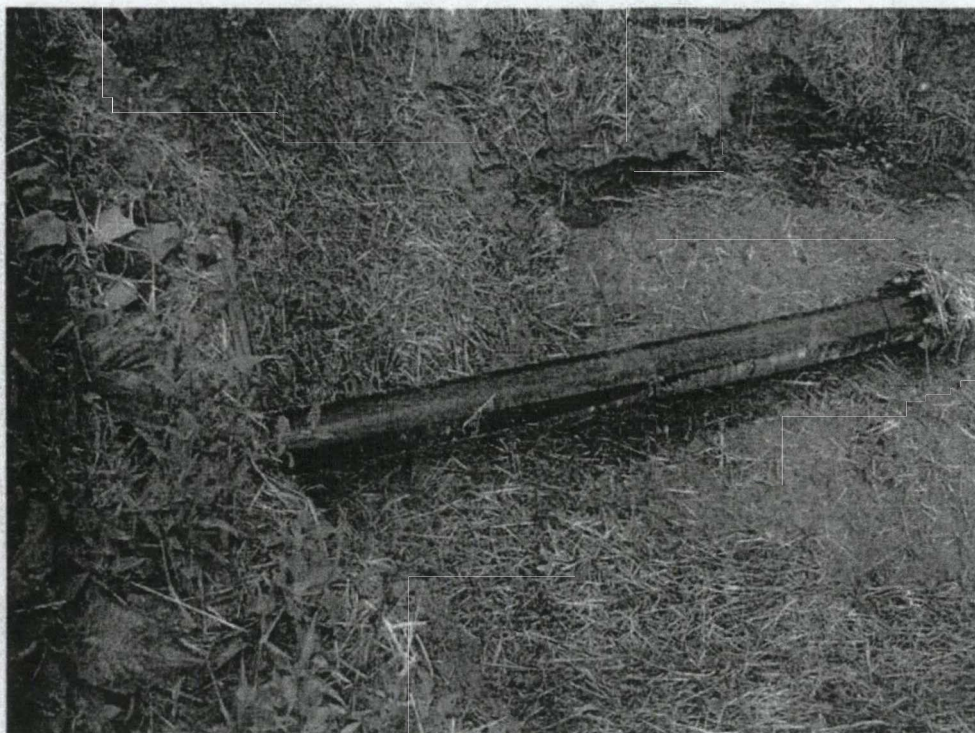
PHOTO #2

Coupling where loose bolts were found and leak occurred. Picture was taken after clean-up and water in low spot at pipe is fresh water.

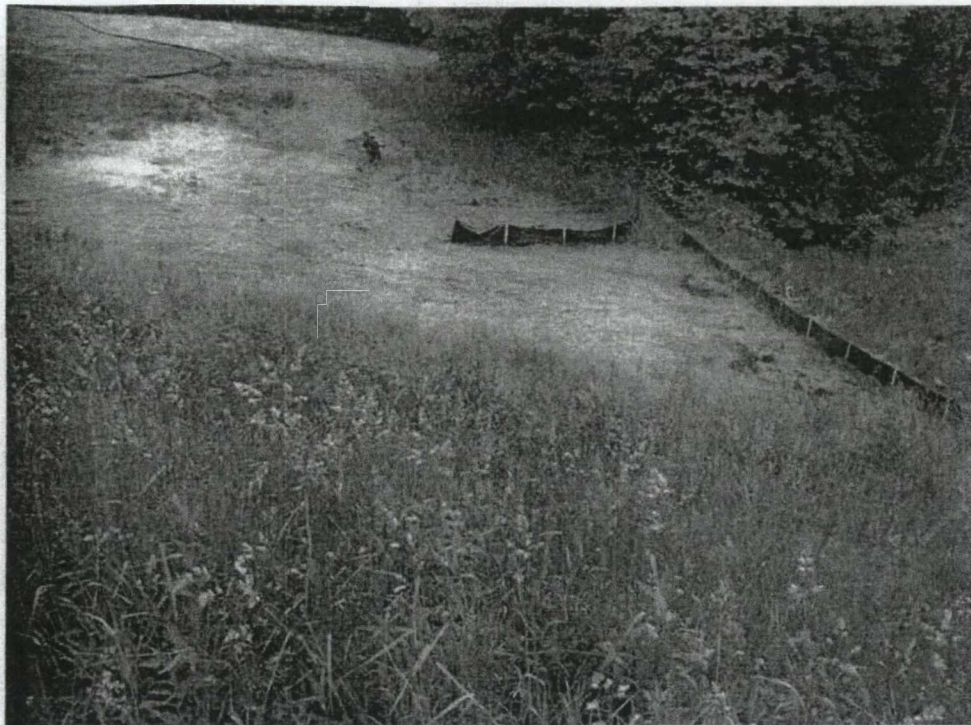
PHOTO #3

Flowback water that was contained by the check dams installed in the unnamed tributary was pumped out by a vacuum truck in locations that were accessible. Additionally, any soil affected by the spill of flowback water was excavated from the area and placed in three lined dumpsters on site. Sampling and analysis of the soil in the dumpsters will be performed to determine the final disposition of the soil. The entire area of disturbance was immediately seeded and mulched. The attached photographs show the area following soil removal and seeding and mulching.

Down slope area affected by spill following clean-up and seeding and mulching

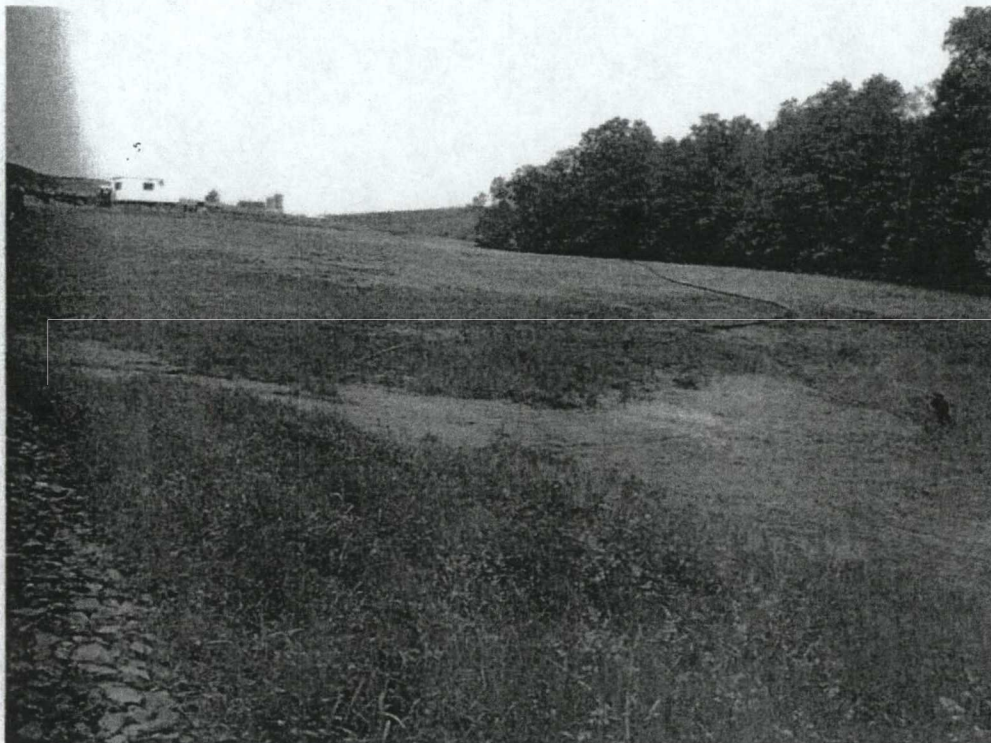
PHOTO #4

Down slope area affected by spill following clean-up and seeding and mulching
